Conservation Area Appraisal

Bryn Eglwys, Gwynedd

Project No. G2675

Report No. 1625

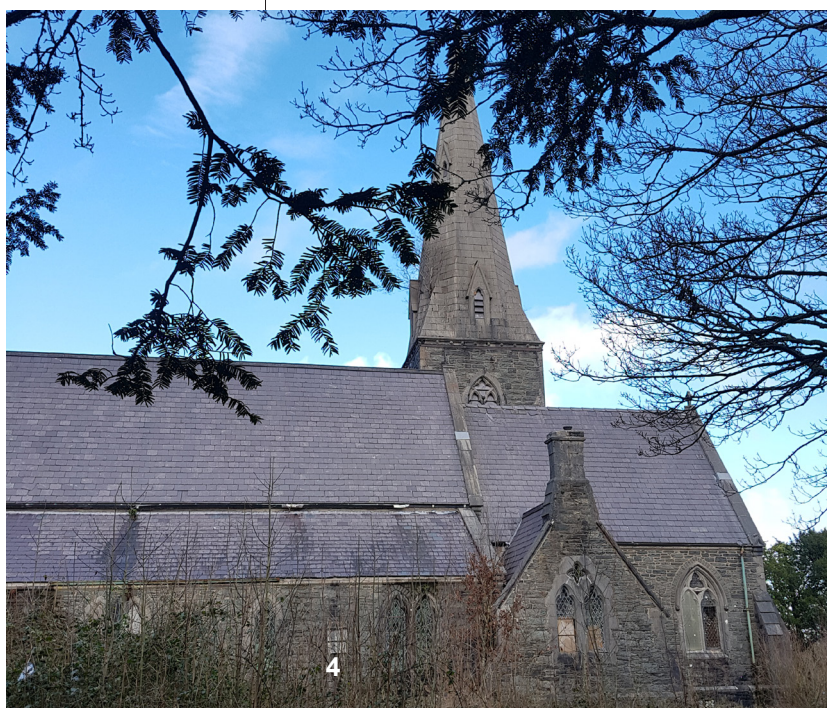
4
North side of St Ann's church showing vegetation growth up to the church and damaged windows.

porch and a north vestry. The two-stage north tower has a tall broach spire. Materials used include dark rubble stone with limestone dressings. The church is in a perilous condition, the spire is supported by an iron tree which is rusting away and is in imminent danger of collapse. Windows are smashed and distorted, rubbish blocks the doorways. The dilapidated gateposts lead into a restricted parking area with a vehicle track encircling the church, with access to the graveyards. Thick brambles lie against the walls and scrub is encroaching. The wider area surrounding the church is relatively impenetrable with maturing trees. The churchyard directly inside the gates and to the left has been maintained and is of importance to the community. Flowers are present on a number of the graves. There has been an effort to control the yew trees on the eastern boundary but only to prevent encroachment on adjacent fields. The church is privately owned, unlisted

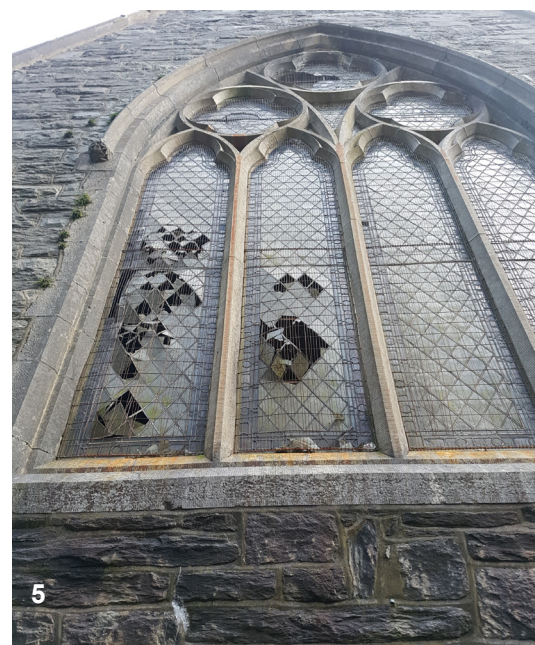
5
Damaged window.

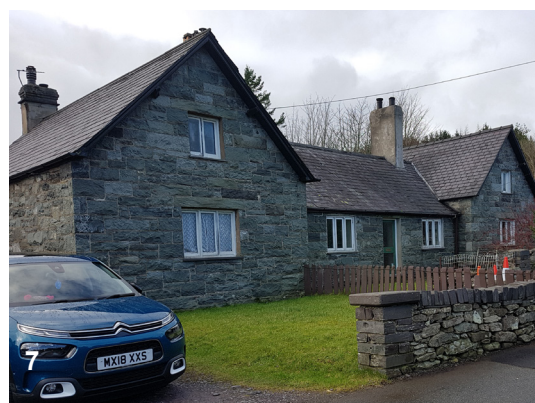
7
No's 5 to 7, Bryn Eglwys

The block is set back from the road with white painted windows with unpainted reveals. The vehicular entrance between 4 and 5 seems to serve 5,6 and 7, with a belt of woodland protecting the settlement to the west. Only one doorway, with a green glass panelled door, is visible from the road, serving the central single storey block (No 6). The front garden to this house is shorter providing a small court that can be a parking space. *Image 7.*

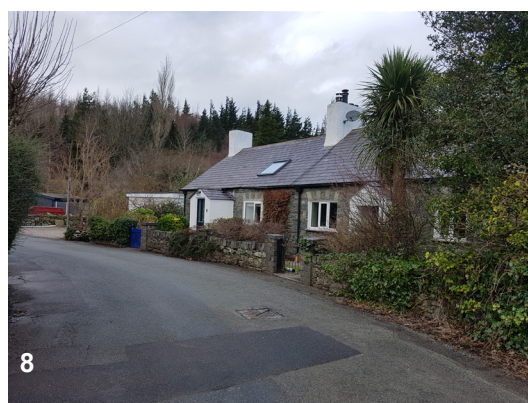
8
No's 10 and 11 Bryn Eglwys.

On the opposite side of the road and just above, on the bend in the road, is another pair of cottages in the same style as No's 1-4. The lower is in relatively original condition with a small open porch, probably a later addition, but in keeping. The front garden retains its wall, gate pillars and gate. The upper cottage "The Milton" has unsuitable UPVC latticed windows and an out of scale porch. It retains the front garden layout but has been extended to the side with a boxy small flat roofed extension. A substantial garage has been built uphill with parking in front. *Image 8*

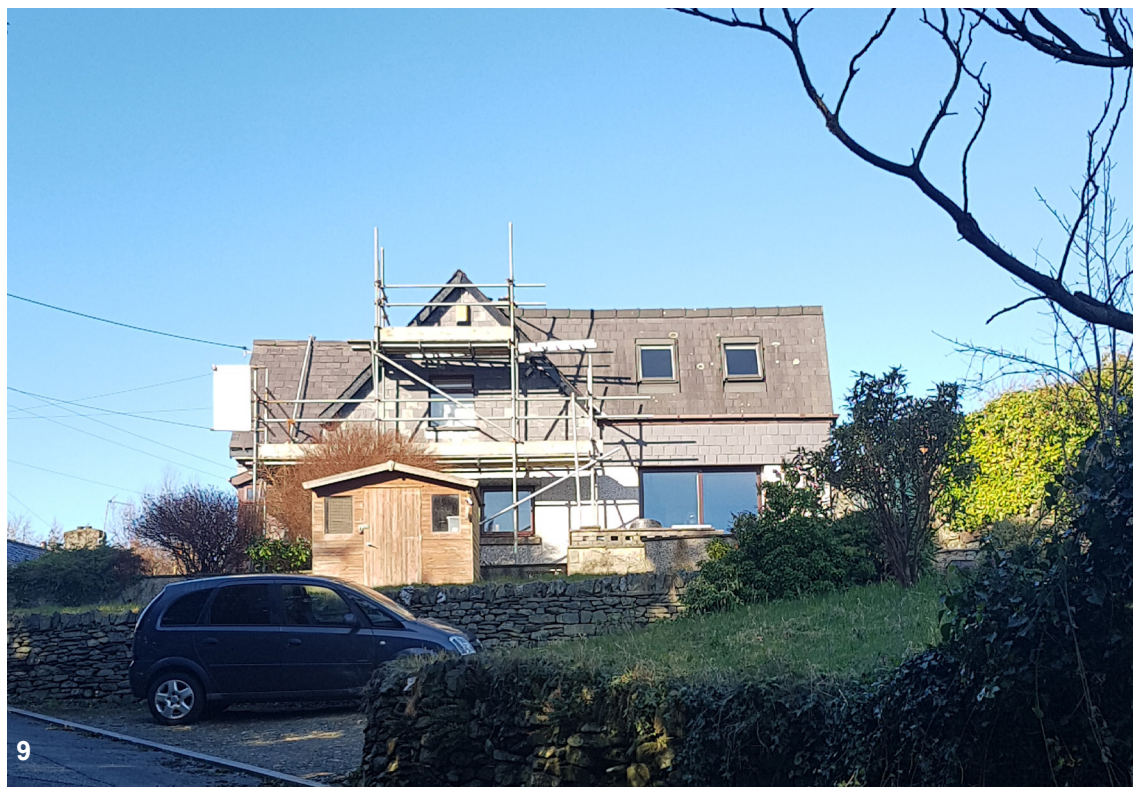
The other building within the Conservation Area is opposite no's 1-2. At the time of the survey this was undergoing redevelopment, but it appears to have started as two cottages, with farm buildings to the rear. It has a central stack and slate roof. Two wings, each of two storeys, project forward, with the upper half slate hung and the lower of roughly coursed stone blocks. There is a new large rear wing visible from the road behind the right cottage. The front garden is similar to those opposite, though it slopes so the front walls retain the soil behind. In its present form the house appears out of scale within the Conservation Area. *Image 9.*

The front garden has been converted into parking, and new uncharacteristic windows inserted.

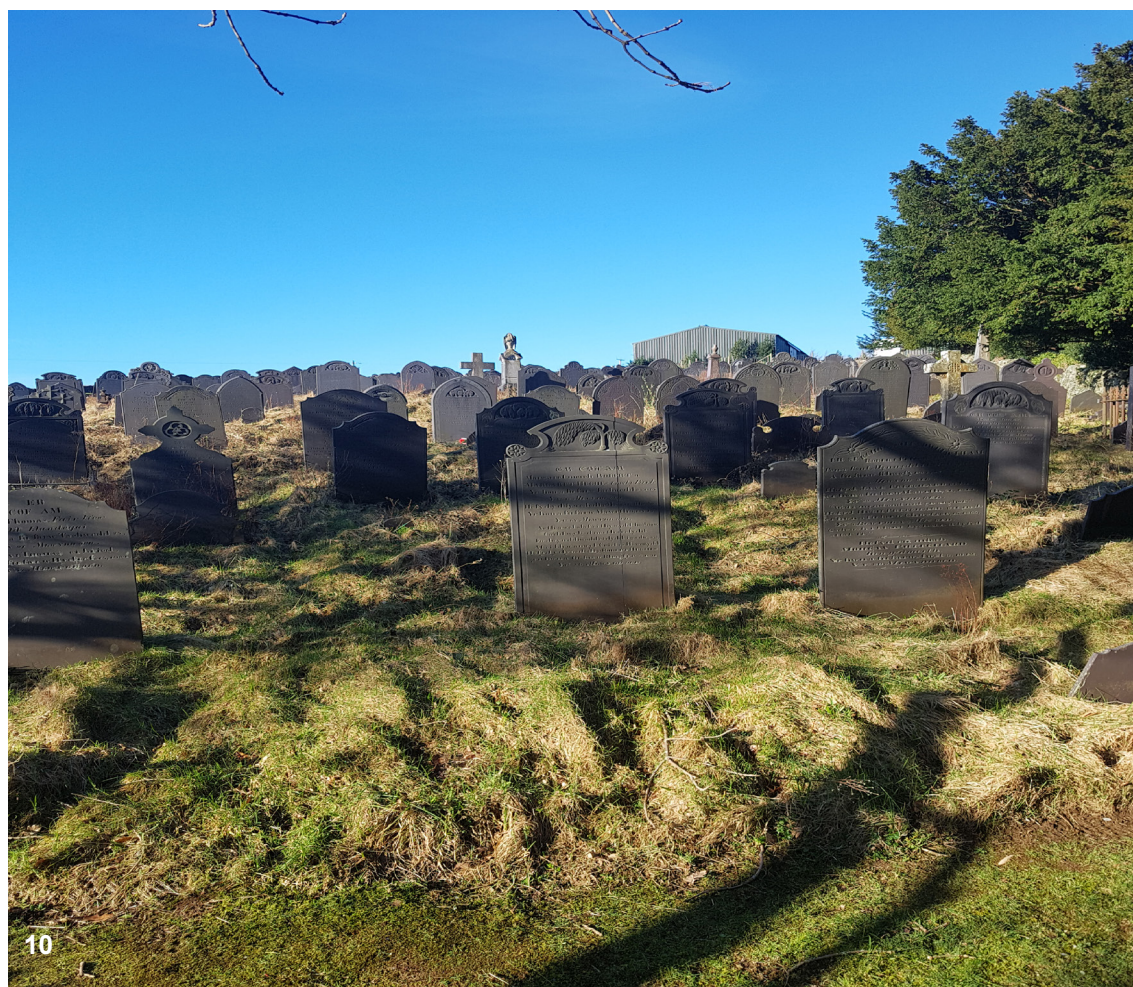
The lower graveyards at St Ann's would make an appropriate extension to the existing conservation area.

The inclusion of the two lower graveyards within the conservation area is logical, and should be considered. They are well managed, and both are obviously of significance to the community. The upper of the two, closer to the church, was established by at least 1900, whilst the larger extension further from the church was established later. *Image 10*
