Conservation Area Appraisal

Mynydd Llandygai, Gwynedd

Project No G2675

Report No. 1644

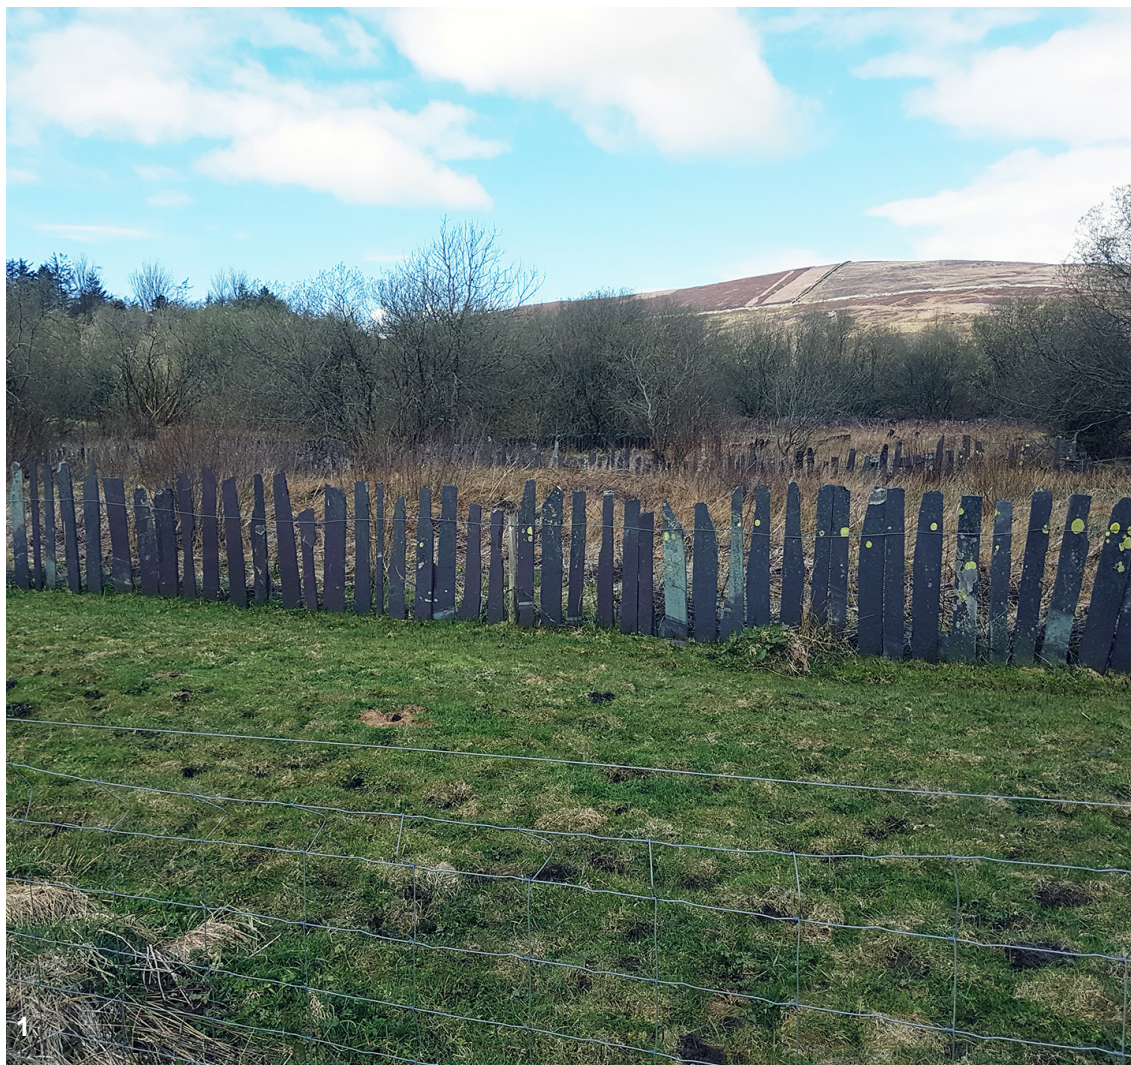
01

Garden plots behind Tan y Bwlch separated by slate fences (crawiau). Looking north-west.

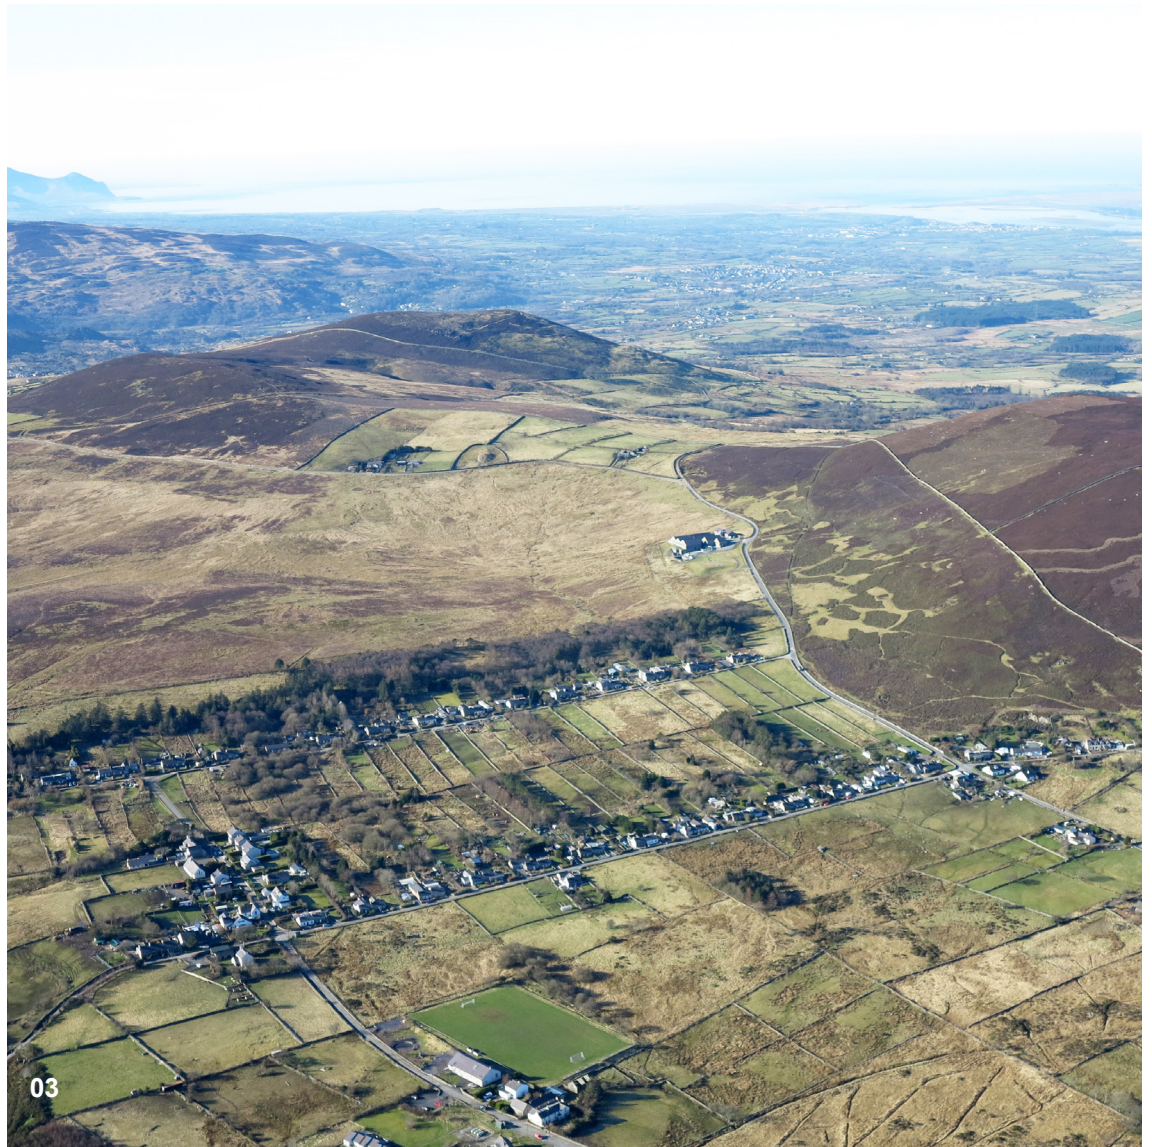
03

Aerial View of the village showing the moorland around, and the regular layout of the settlement.

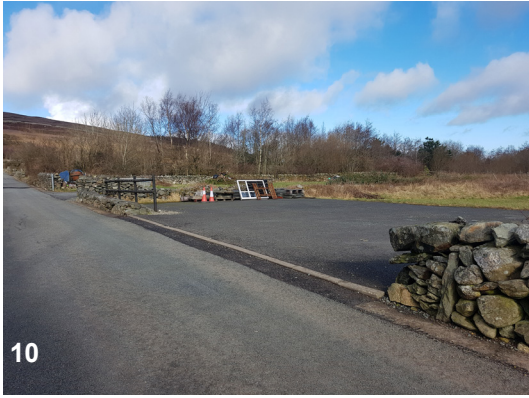
10

No 14 has been heavily extended and has a large double garage set in a substantial area of tarmac. Pavers mark the area between the road and the gateposts, an unnecessary

change in materials but most unfortunately, across the road, a rectangular area of parking has been tarmacked and edged. *Image 7.*

Large area of tarmac laid opposite No. 14 Tan y Bwlch

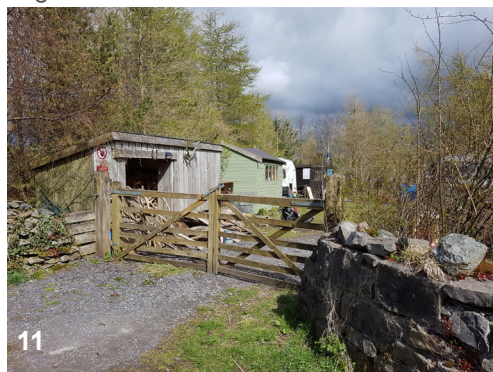
11

Area opposite Nos 26 and 27.

Opposite the wall has been rebuilt to form an interned gateway with double gates. A shed has been built and the area occupied for storage, parking etc. The boundary with Hermon road consists of dilapidated wooden fencing giving way to a wire fence. *Image 11*

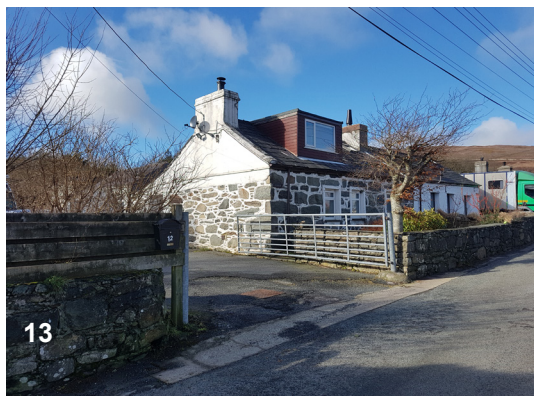
No 12 is possibly one of the more jarring properties on the road, having a brown wood dormer window on the front aspect and the overlarge pointing has been painted white, giving a piebald effect to the façade. The door is replaced by a window, the garden walls are topped with flat concrete. No 11 is flat rendered, the door replaced by a window and end chimney removed. *Image 13.*

13
No. 12 Llwybr Main
with dormer window

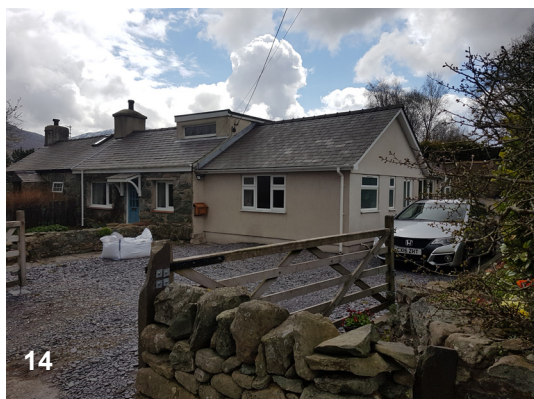
added to the side. However, the front has been subtly altered by removing the side wall of the front garden. No 9 has a very unfortunate high set forward facing dormer window, one enlarged front window and a side extension two thirds the length of the cottage. The end chimney is also missing. *Image 14.*

14
No. 9 Llwybr Main
with dormer window
and extension

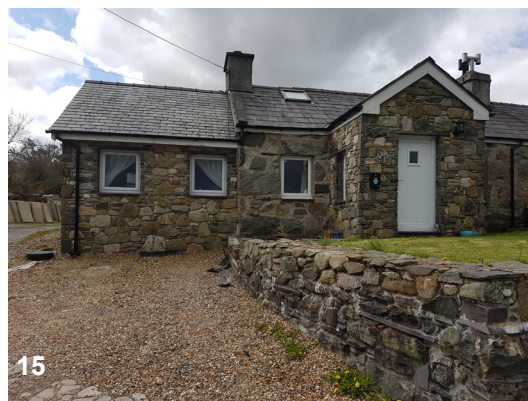
15
No. 2 Llwybr Main
with new extension

stepped down roofline and an inappropriate eaves overhang. The large-windowed stone porch is out of scale with a cottage of this type and has helped to gentrify this property. *Image 15*

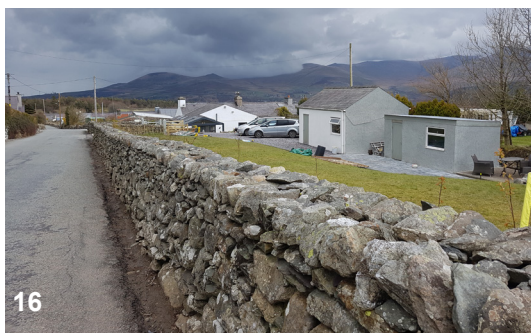
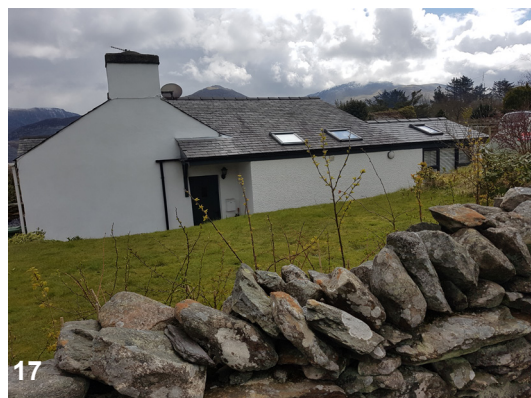
16
No. 1 Llwybr Main

17
No. 1 Llwybr Main

No 1 has lost its door and access is via a garden gate and path, to a side door. A back extension protrudes sideways, with a long catslide roof. This is unfortunate as it is, with an added conservatory, bigger than the cottage itself and a dominating feature from the corner with the road to Deiniolen. This visual intrusion is compounded by a side vehicular entrance with interned walls, into the allotment where a tall garage and dog enclosure have been built in a large area of hardstanding. The lack of any planting to mute the view of the additions makes it all the more obvious. *Images 16, 17*
