# Conservation Area Appraisal Bethesda

## Conservation Area Appraisal Bethesda

Project No G2675

Prepared for Cyngor Gwynedd Council

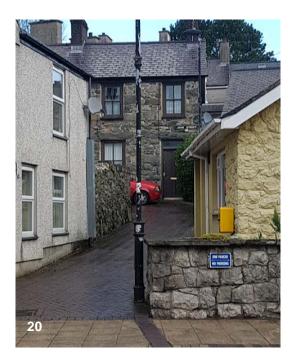
The essential character of this Conservation Area is the irregular and winding nature of the lanes and paths. John Street is the central through-way, not accessible to traffic and now paved. It contains a mixture of one and two storey houses. *Image 20*

Mixed styles within Lon y Graig

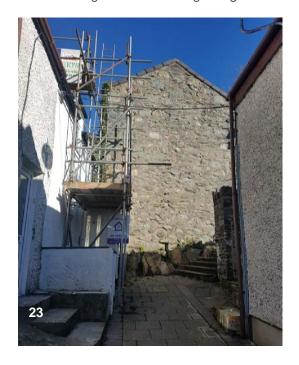
A large stone building on the west side of John street and at the junction with Grisiau Mawr, the flight of steps descending to the High Street, is windowless on the southern and western aspects. The stonework is exposed and suggests an industrial origin for the building. *Image 23*

Building at junction of John St with Grisiau Mawr.

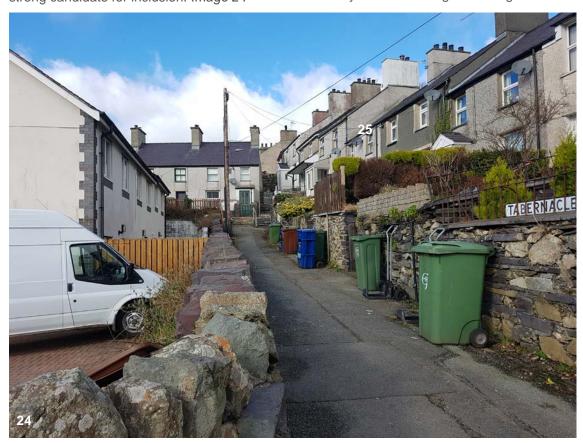
Rhes Gordon is a terrace of houses distinguished by a continuous veranda supported by cast iron posts and decorated spandrel brackets. At each end is a larger block consisting of two houses, with a projecting wing containing two forward facing sash windows, the northerly of these has a porch added under the veranda, probably in the early C20th, and has a basement. The terrace is constructed from rubble stone set in a crazy paving pattern with red brick facings. The houses are set back from the road by narrow rectangular front gardens

separated from each other by a mixture of brick walls and iron railings. The front walls are built of roughly coursed stone, topped with well-constructed iron railings with matching gates. *Images 25, 26, 27*

Rhes Gordon looking south-east.

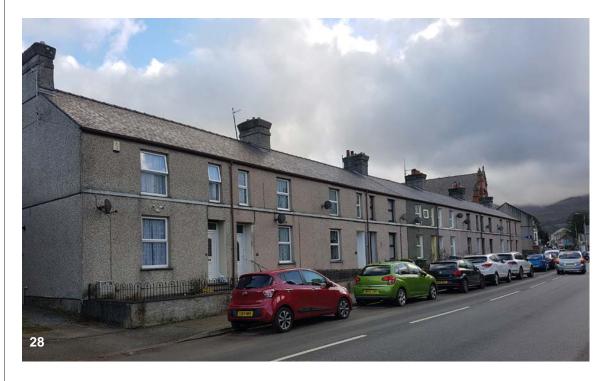
course. There is a plaque in the centre of the terrace citing the name and date in a shaped plaster surround, which matches the string course in style and dimensions. Apart from this restrained detailing the terrace is quite plain. Windows would originally have been four pane sash widows, all of which have been replaced. Each house has a narrow front yard with a low slate topped, pebble-dashed wall with decorative railings set into the slate. A short path and slate steps led up to the front door. A transom light above the door is still evident in most of the houses although all doors have been replaced with modern UPVC ones. Back gardens are modest in size. Images 28, 29

28
Rhes Elfed looking south-east with Capel Bethania beyond.

29 Rhes Elfed.

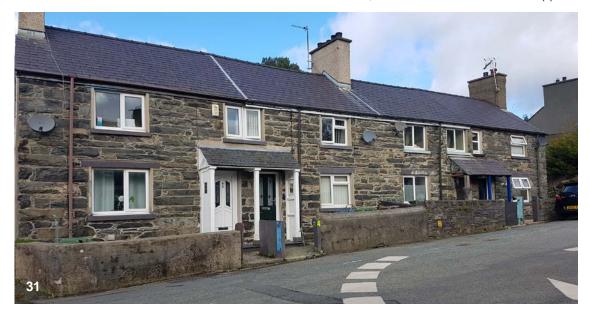
mono-pitch with an open wooden structure, others have hipped roofs. *Image 30*

30
No's 4 to 6 Penybryn
with porches and
slate lintels to
the ground floor
windows.

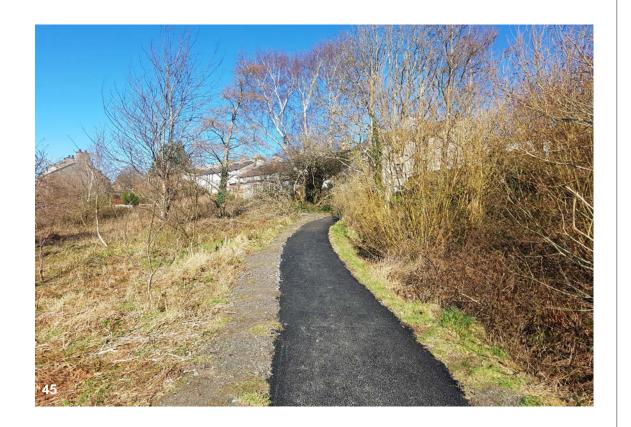
At the bottom of Goronwy Street are a series of footpaths through open land, with slate fences at the bottom where the path joins Fordd Abercaseg. The land is privately owned but used by the community in part to gain access to the popular swimming ponds on the River Caseg. The paths have recently been heavily tarmacked and slate fences towards Gwernydd at the south eastern edge of the open ground have been removed and damaged. *Image 45*

John Ll. Williams and Lowri W. Williams, Hanes Dyffryn Ogwen Website https://hanesdyffrynogwen.wordpress.com/ 45 Open land southwest of Goronwy Street
