Conservation Area Appraisal Tanysgafell, Gwynedd

Project No G2675

Report No. 1688

Prepared for Cyngor Gwynedd Council

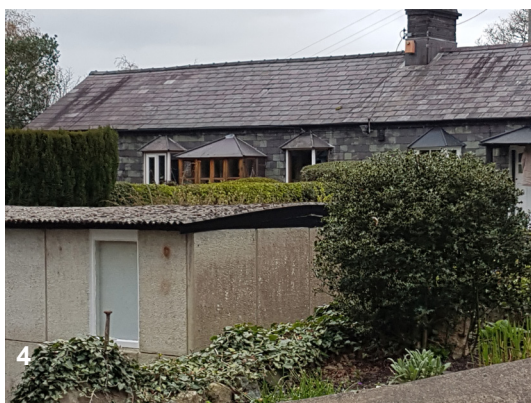
4
No. 6 Tanysgafell.

No 6, since the listed building report, has acquired a very out of character timber porch and all the windows in the row appear now to be plastic. *Image 4*

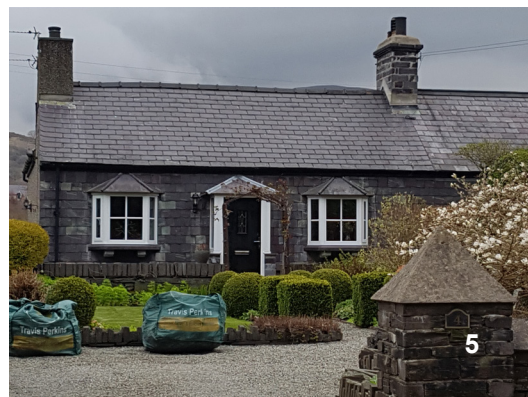
5
No. 4 Tanysgafell.

No's 3 and 4 retain the majority of original features, and are in good repair. No 4 has a particularly fine garden. *Image 5*.

The front plots have been much altered, to allow for the parking of cars, including the building of garages and sheds. Much of this development runs across the plot, where a lengthways axis would be more fitting. This has fragmented the foreground, distorting and detracting from the view of the cottages. *Images 5, 6, 7*

Further development of the front plots should be closely monitored and homeowners should be made aware of appropriate guidance.

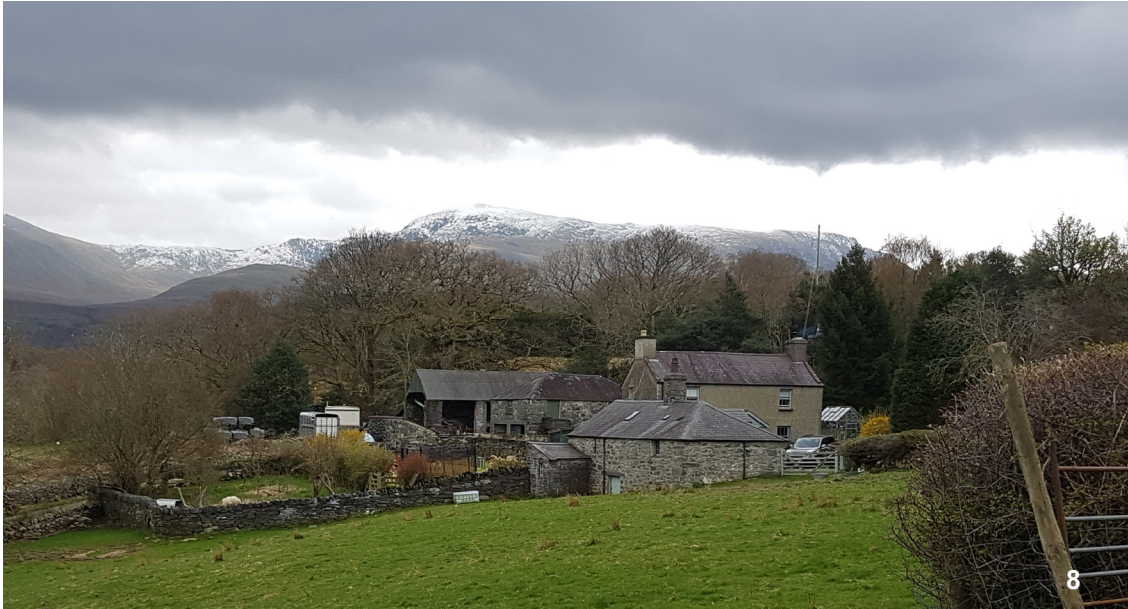
8
The farmstead at
Tynyclwt Uchaf

Beyond the cottages, to the north is the farm of Tynyclwt Uchaf, this is set at an angle to the cottages and back from the road. It was built earlier than the cottages. The farm buildings and house are well maintained and the former are largely unmodernised. *Images 8, 9*

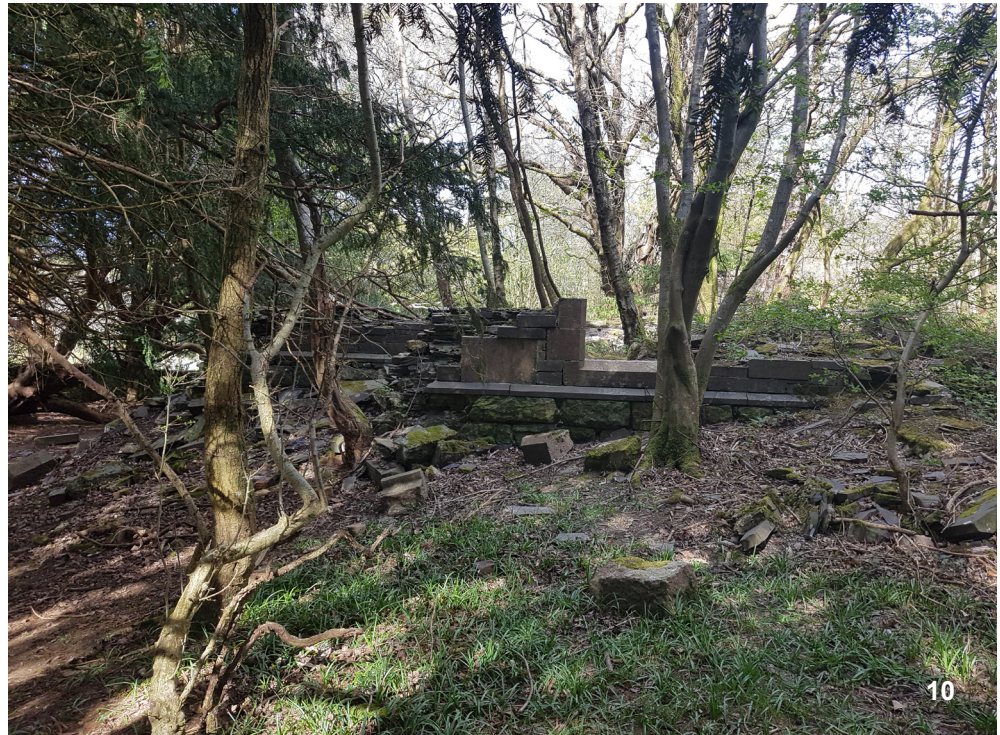
The only desirable change to the Conservation Area would be to include the abandoned churchyard within the conservation area. It is in an area of mature woodland and does not appear to be threatened unless further development is planned at the Coed y Parc Industrial Park. However, there is still plenty of evidence amongst the trees including a complete circuit of yew trees, a substantial graveyard including graves of former inhabitants of Tanysgafell, and the ruins of the former church. The latter does not survive much above foundation level, but contains a significant amount of fallen masonry alongside. *Image 10*.
